Unexpected Asbestos Finds Protocol

The following document details protocols of what must be done if asbestos containing material (ACM) or potentially asbestos containing materials (PACM) are unexpectedly encountered during construction activities undertaken at the Bankstown Airport or Camden Airport sites.

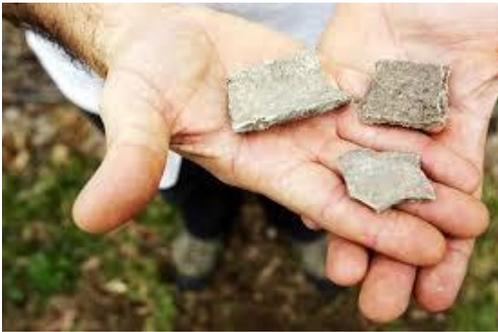
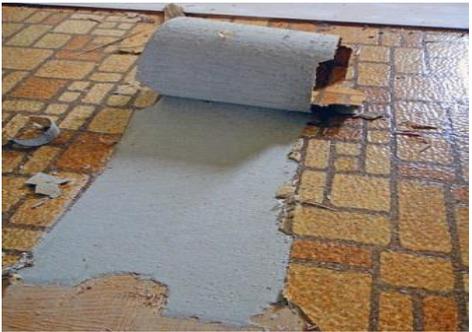
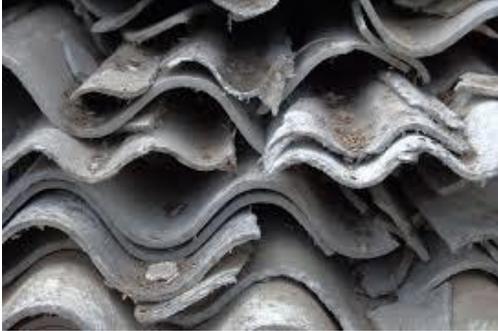
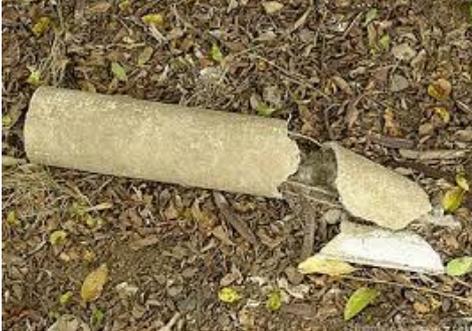
Bonded or 'Non-friable' Asbestos	
Picture Examples

Descriptions	<ul style="list-style-type: none"> • Colour dependant on building material matrix, typically white-grey. • Fibrous edges or 'torn cardboard' appearance on broken edges.

Bonded or 'Non-friable' Asbestos	
	<ul style="list-style-type: none"> • Fibre cement sheeting has dimpled surface. • Cannot be crushed or broken up with hand force.
Common Forms	<ul style="list-style-type: none"> • Construction materials up to 15 years and older. • Fibre cement sheeting / cladding (i.e. fibro). • Vinyl products (floor tiles). • Fibre cement corrugated roofing material (i.e. Super 6). • Fibre cement guttering and pipework. • Electrical backing boards.
Non-bonded or 'Friable' Asbestos	
Picture Examples

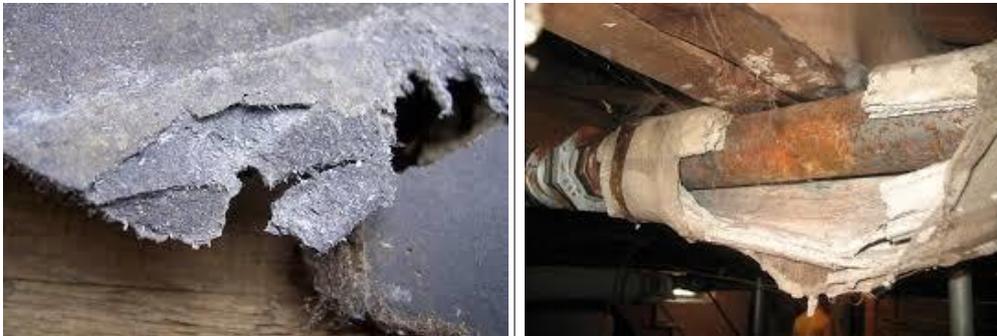
Descriptions	<ul style="list-style-type: none"> • White, grey, blue or dirty fibrous material. • Fluffy. • Easily crushed with finger pressure.
Common Forms	<ul style="list-style-type: none"> • Insulation. • Weathered/damaged fibre cement sheeting. • Fibrous clumps of material.
